**TRANSPORTATION SCIENCES CENTER
ACCIDENT RESEARCH GROUP**

**CALSPAN ON-SITE AIR BAG DEPLOYMENT INVESTIGATION
CALSPAN CASE NO. 95-21
VEHICLE: 1995 DODGE CARAVAN
LOCATION: MARYLAND
CRASH DATE: [REDACTED] 1995**

This on-site investigation focused on a child fatality that resulted from the deployment of the passenger side air bag in a 1995 Dodge Caravan. The 7 year old female child occupant was the right front passenger in the Caravan that was occupied by the 43 year old male driver and two additional child occupants seated in the second seat of the seven passenger vehicle configuration. On an approach to a four-leg intersection, the driver was momentarily distracted and failed to detect a red signal phase. He braked, however, the full frontal area of the Caravan impacted the left side area of a 1992 Chevrolet Lumina APV which resulted in deployment of the Dodge's supplemental driver and passenger side air bags. The right front child occupant was out of position in a forward direction as a result of the pre-crash braking force and within a close proximity to the passenger side air bag module assembly. The deploying air bag contacted the underside of her chin, face, anterior neck, an

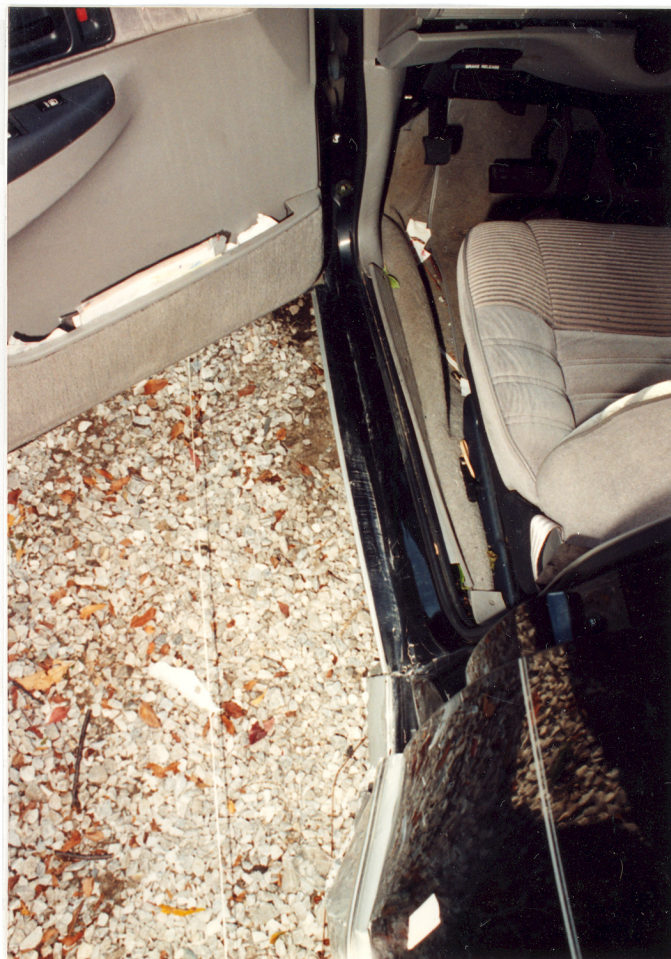
79. Lateral displacement of the left sill of the Lumina.
